Report Number: 214-TRC-06-001

**Safety Compliance Testing For FMVSS 214**

**Side Impact Protection**

**General Motors De Mexico  
2006 Chevrolet HHR MPV**

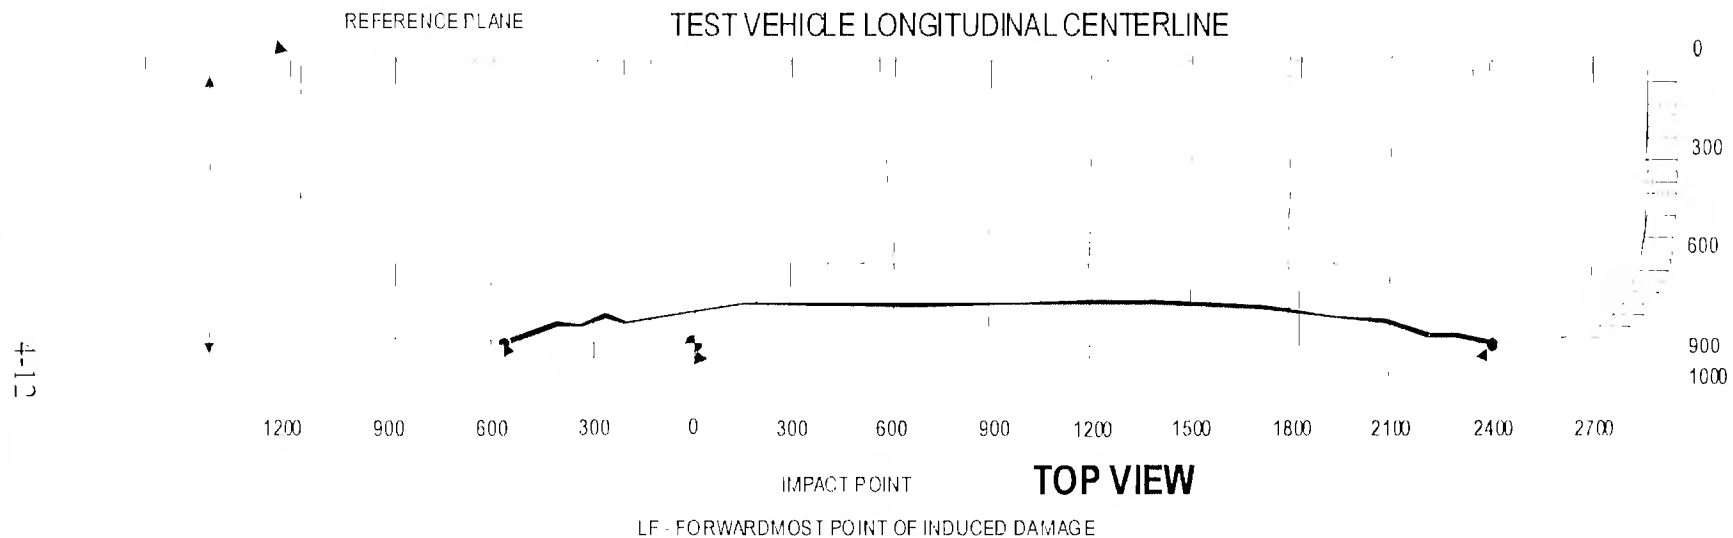
## Vehicle Damage Profile Distances

NOTE: All measurements were recorded using TRC Inc.'s FARO Arm with a tolerance of plus or minus 0.1 mm.

Full length of induced damage was 2100 mm.
